Fault detection in a centrifugal pump using vibration and motor current signature analysis

Reference to this paper should be made as follows: Mohanty, A.R., Pradhan, P.K., Mahalik, N.P. and Dastidar, S.G. (2012) 'Fault detection in a centrifugal pump using vibration and motor current signature analysis', *Int. J. Automation and Control*, Vol. 6, Nos. 3/4, pp.261–276.

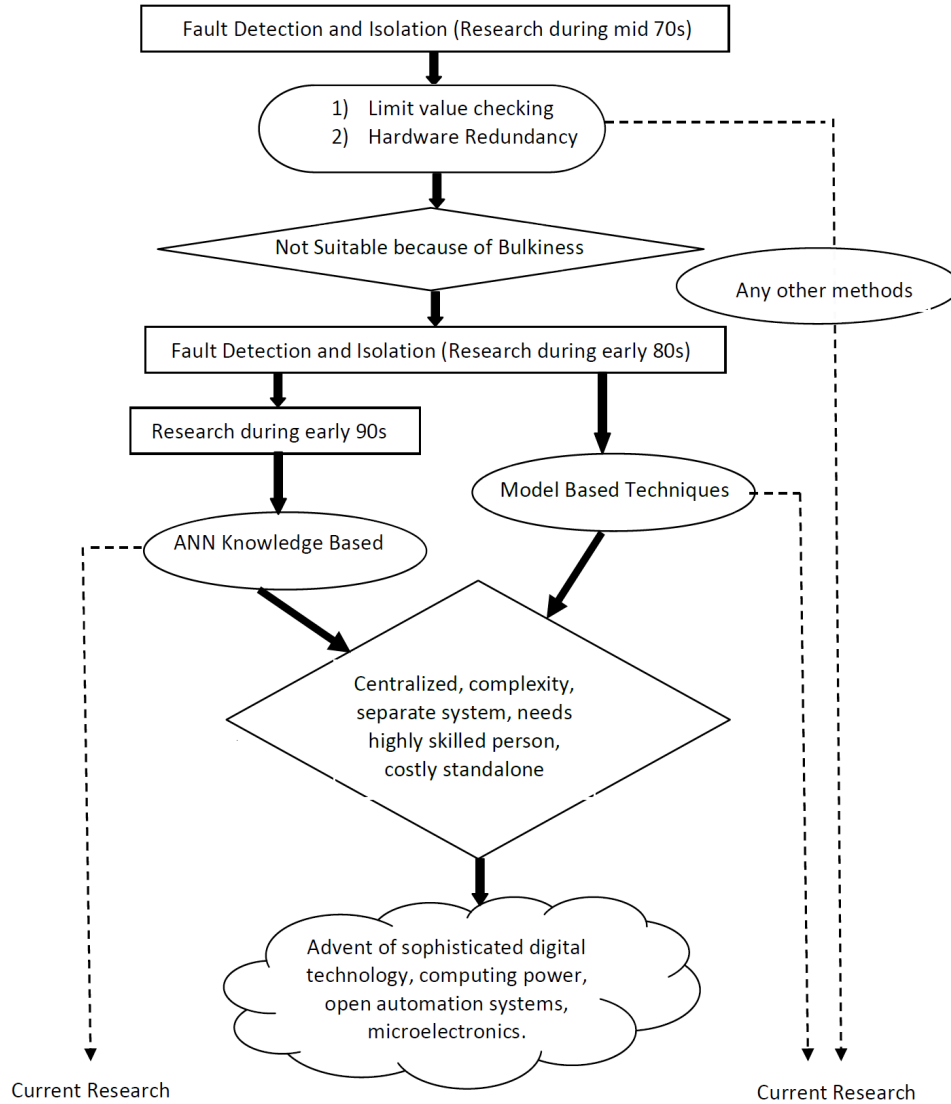
Figure 1 Progress on FDI

Next generation industrial systems will require more reliability, availability, safety, and embedded control strategy in response to provide highly customised products. The benefits that have been achieved so far through implementation of condition monitoring are now being significantly extended through the application of new theories, techniques, tools, and methods. Advances in computing tools and techniques have stimulated studies to design as well as realise autonomous machinery systems. Fault detection and isolation (FDI) is the main research topic that fall under the category of condition monitoring (Mohanty and Mahalik, 2007, 2011). Figure 1 (Mahalik et al., 1998) illustrates the progress on condition monitoring methods.

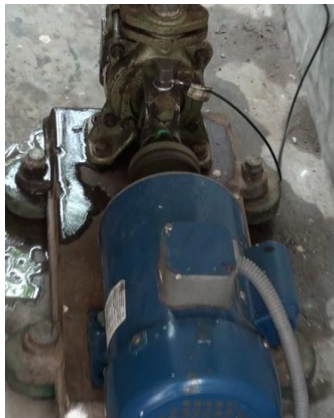
Figure 2 Accelerometer mounted on a pump (see online version for colours)

The accelerometer (PCB 353B33) was placed on the casing of the pump close to the bearing (as shown in Figure 2) to measure the vibration. Hall effect sensor (Tektronix A621, as shown in Figure 3) was kept around the phase terminal of motor current to measure the instantaneous motor current. The centrifugal pump (0.75 kW, 1,450 RPM, 240 V, make-Crompton Greaves, as shown in Figure 2) was operated under different working conditions of impeller like normal impeller (all vanes present), one vane broken impeller, two vanes broken impeller, three vanes broken impeller (as shown from Figures 4 to 8) sequentially.

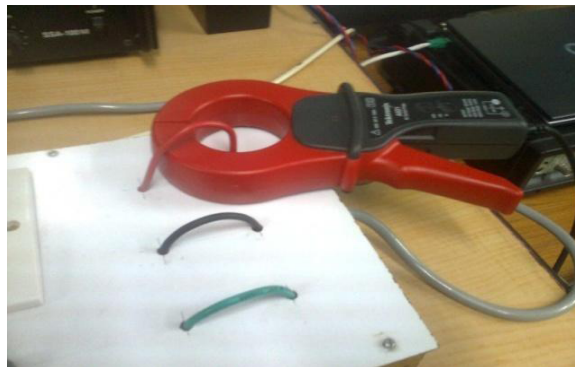
Figure 3 Hall effect sensor (see online version for colours)

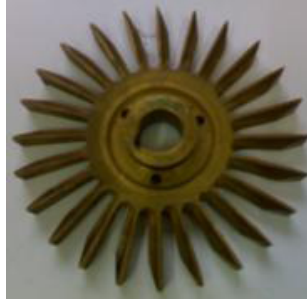
Figure 4 Normal impeller (see online version for colours)

Specification of the impellers used in pump is made of brass; with external diameter 100 mm; width 10 mm; vane length 25 mm and number of vanes are 24. The diameter of impeller hub is 13 mm. The experimental work has been performed in the following sequence:

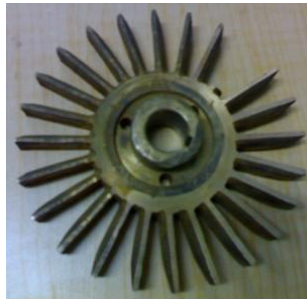
Figure 5 Broken impeller (one vane missing) (see online version for colours)

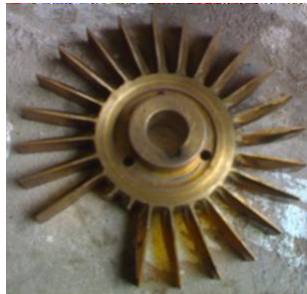
Figure 6 Broken impeller (two vane missing) (see online version for colours)

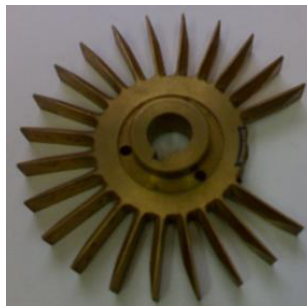
Figure 7 Broken impeller (three vane missing) (see online version for colours)

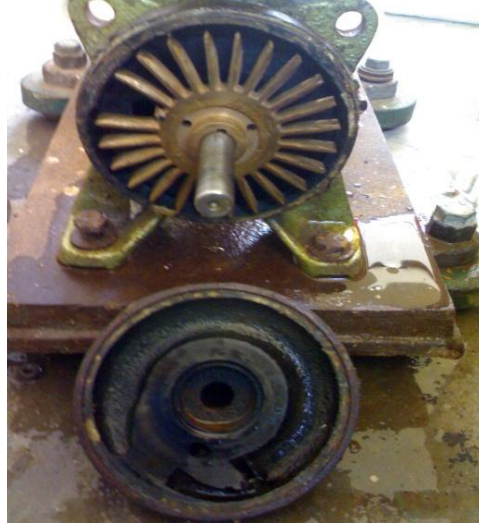
Figure 8 Broken impeller inside casing of the centrifugal pump (see online version for colours)

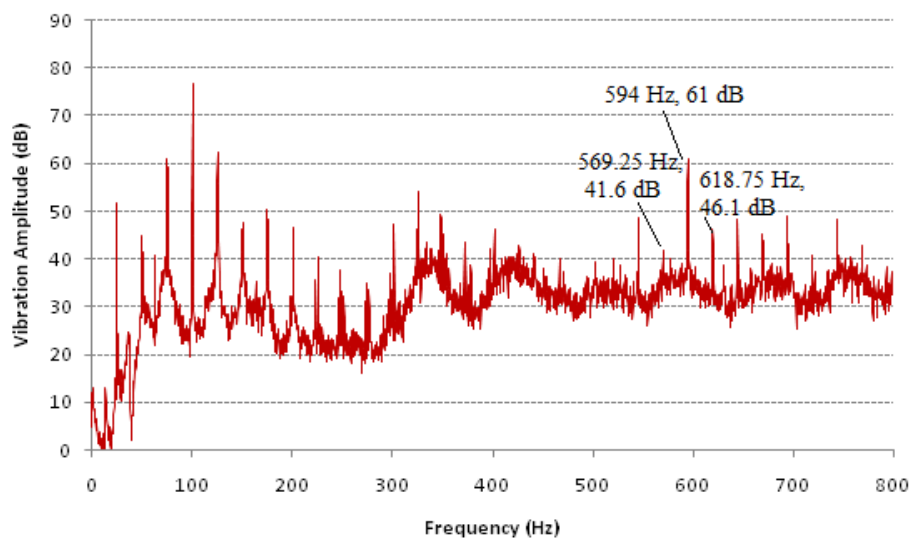
Figure 9 Vibration spectra of the normal impeller (see online version for colours)

From the vibration spectra it has been observed that the first high peak was at 24.75 Hz (52 dB) which happens to be the rotational speed (RPS) of the pump. This measurement was verified by an optical tachometer which indicated a rotational speed of 1,485 RPM. Also, the presence of VPF (i.e., $RPS \times \text{No. of vanes}$) was observed in the vibration spectra. Their corresponding amplitudes (in dB) and their SBs (at $VPF \pm RPS$) for different impellers were noticed. The observations of vibration spectra (as shown in Figures 9 to 12) for different impellers are summarised in Table 2.

From Table 2, it is observed that when the severity of the defect increases, height of SBs increases and the difference between the dB values of VPF and SBs decreases. Like as the severity of the rotor bar fault increases, the height of SB's peak increases (Thomson and Fenger, 2001). As vane/vanes of impeller of pump has/have been broken, the momentary torque exerted between two consecutive normal vanes (in between whose, vane has been broken) rises. Due to that, the amplitude of force as well as vibration at $(VPF \pm RPS)$ increases. So, the peak height at $(VPF \pm RPS)$ also increases.

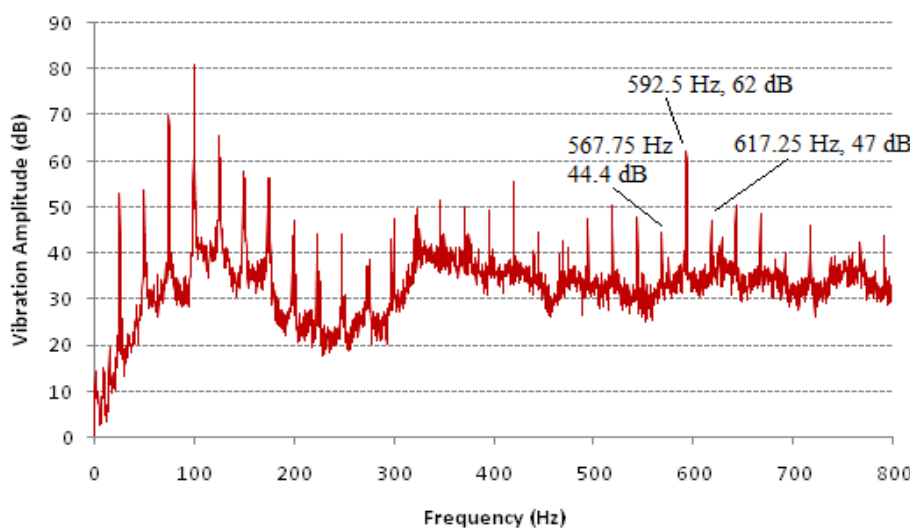
Figure 10 Vibration spectra of the defective impeller (with one vane missing) (see online version for colours)

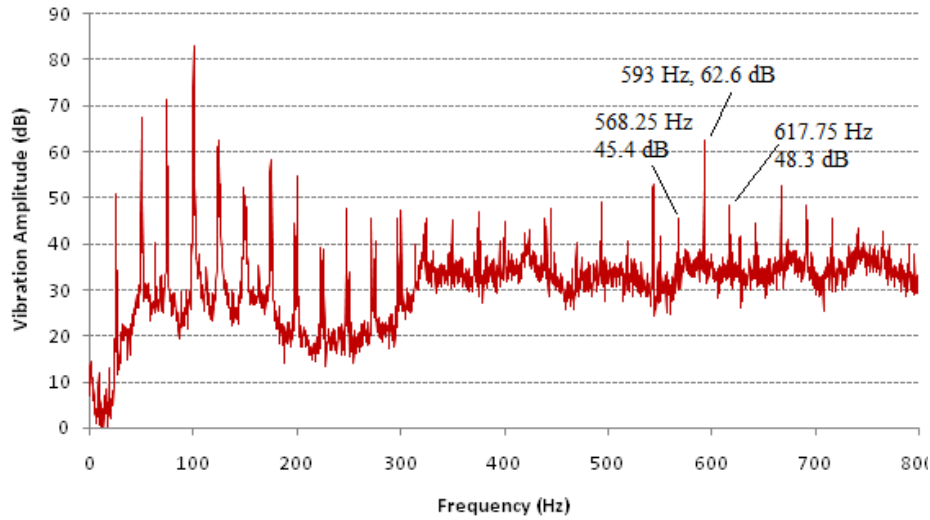
Figure 11 Vibration spectra of the defective impeller (with two vanes missing) (see online version for colours)

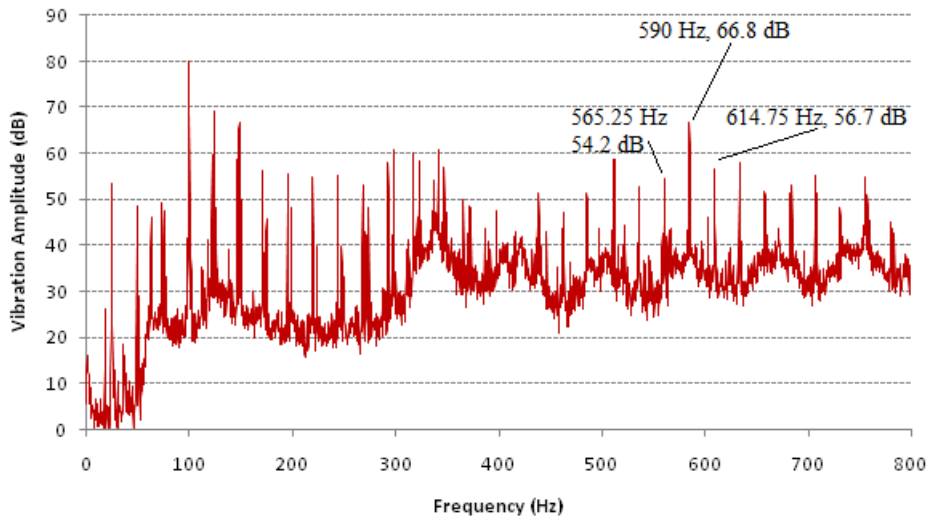
**Figure 12** Vibration spectra of the defective impeller (with three vanes missing) (see online version for colours)

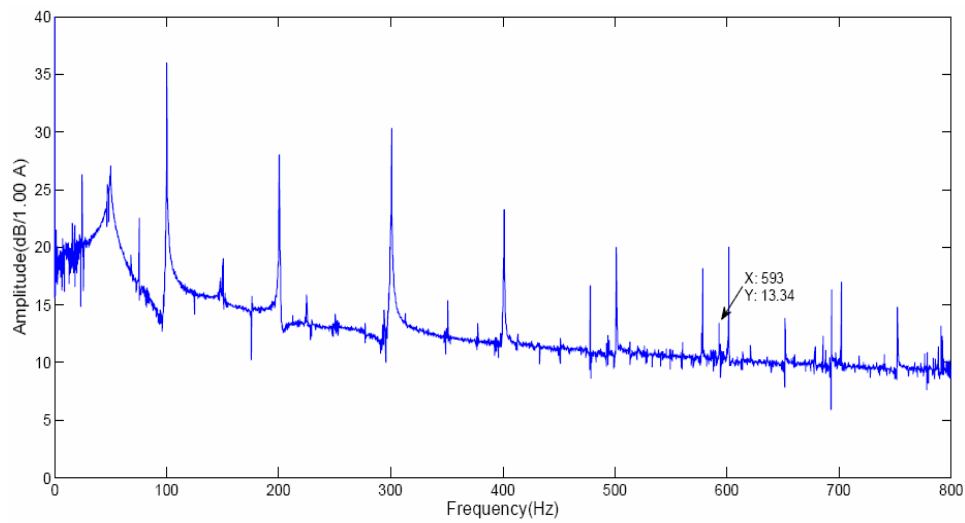
Figure 13 Demodulated current spectra of the normal impeller (see online version for colours)

From Figures 13 to 16, the VPFs and their respective amplitudes are summarised in Table 3. It is observed that when the severity of the defect increases, then the amplitude of the demodulated current signal at VPF increases.

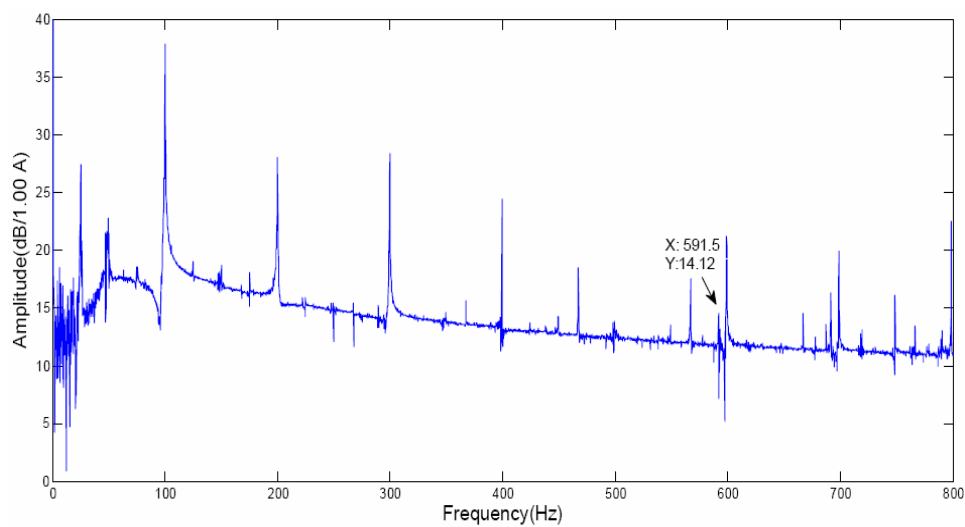
Figure 14 Demodulated current spectra of the defective impeller (with one vane missing) (see online version for colours)

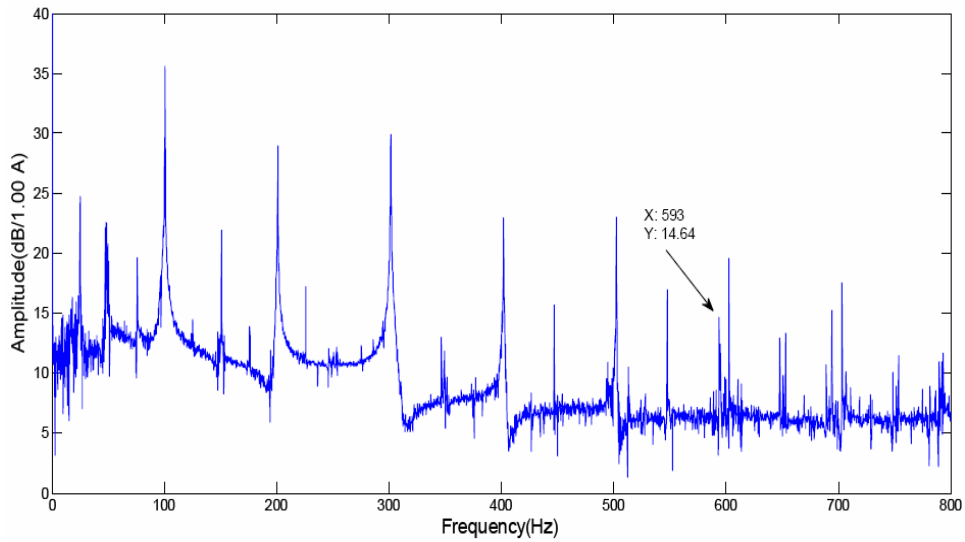
Figure 15 Demodulated current spectra of the defective impeller (with two vanes missing)
(see online version for colours)

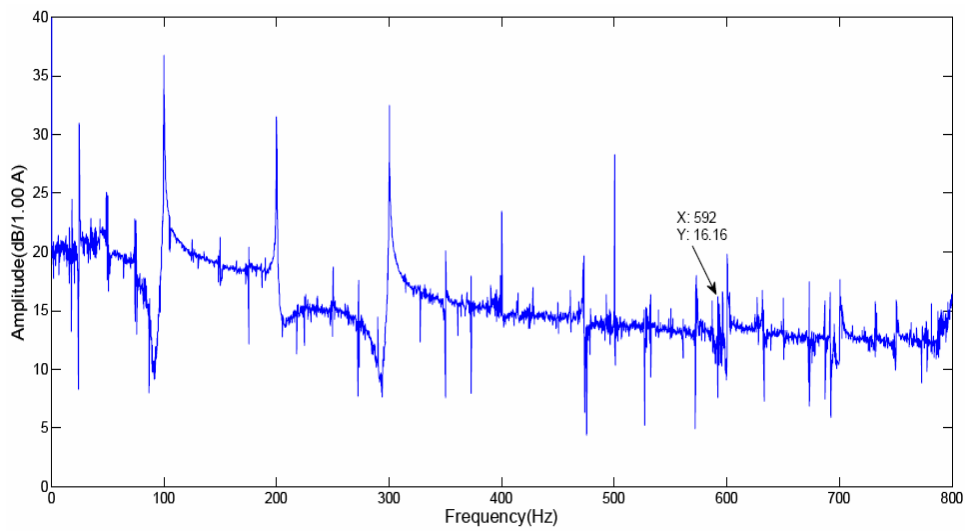
Figure 16 Demodulated current spectra of the defective impeller (with three vanes missing)
(see online version for colours)

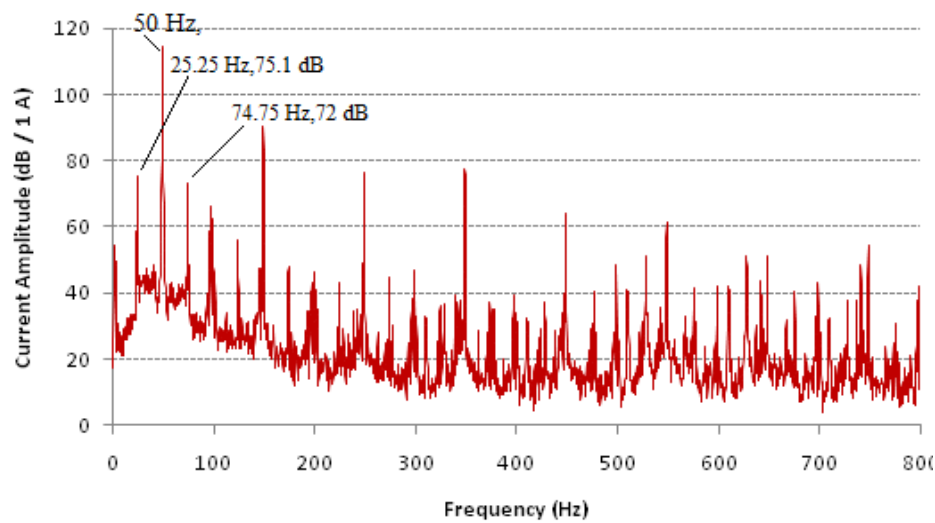
Figure 17 Current spectrum (see online version for colours)

From the current spectrum (as shown in Figure 17), it was observed that the second (and highest) peak gives the supply frequency (in this case 50 Hz).

Also, the current spectrum has been used to find out the rotating speed (RPS). From the current spectrum, it was observed that peaks are at supply frequency (50 Hz) and two SBs at $50 \pm$ RPS. These are at 25.25 Hz (75.1 dB) and 74.25 Hz (72 dB) respectively. The SBs occur because of the modulation of the current, due to variation in the air gap between stator and rotor during rotation of motor shaft. Since the rotational vibration which in turn varies the magnetic conductance and due to that instantaneous current signal is modulated. When it is demodulated in frequency domain, it shows as SBs around supply frequency.
